**Title of Thesis:** *Modes of Rock Slope Movement in the Colin Range, Jasper National Park*

*Modes of Rock Slope Movement in the Colin Range, Jasper National Park*

Department of *Earth and Atmospheric Sciences*

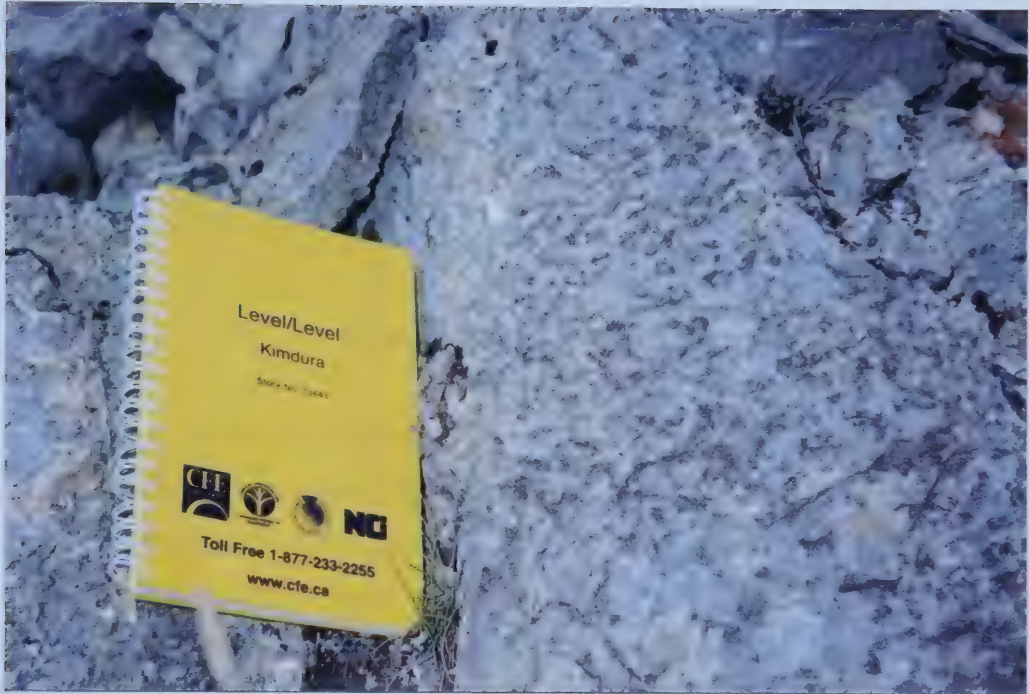
Figure 4.33 – Dolomitic mottling of the Palliser Formation limestone, with a notebook for scale.

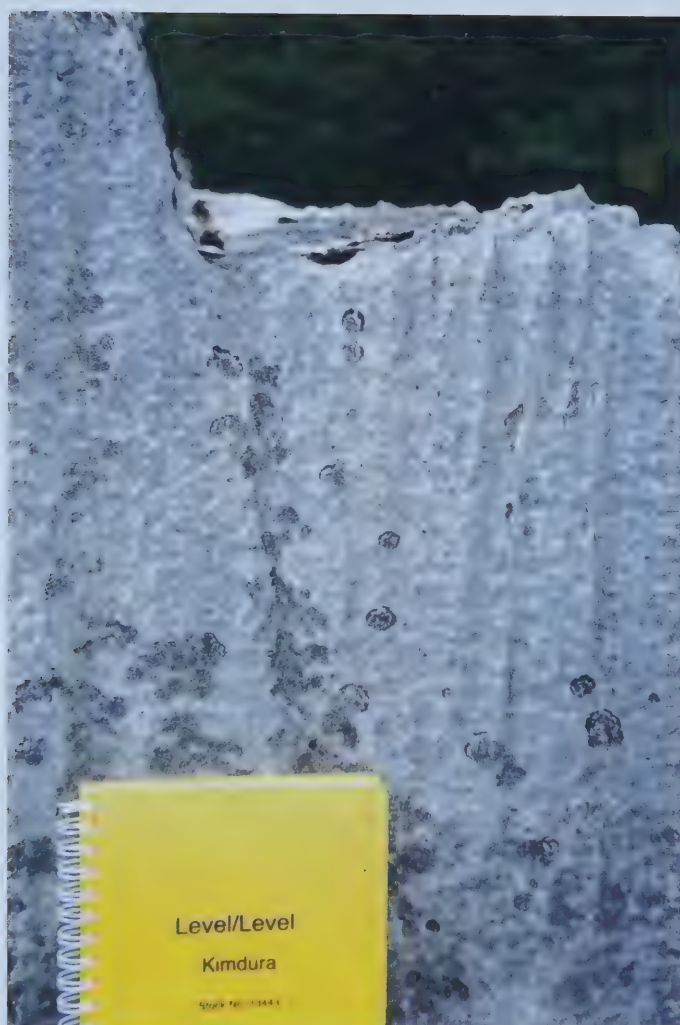
Figure 4.34 – Karren on the vertical surface of a boulder within the downslope colluvial area of the Rock and Boulder Gardens, with a notebook for scale.

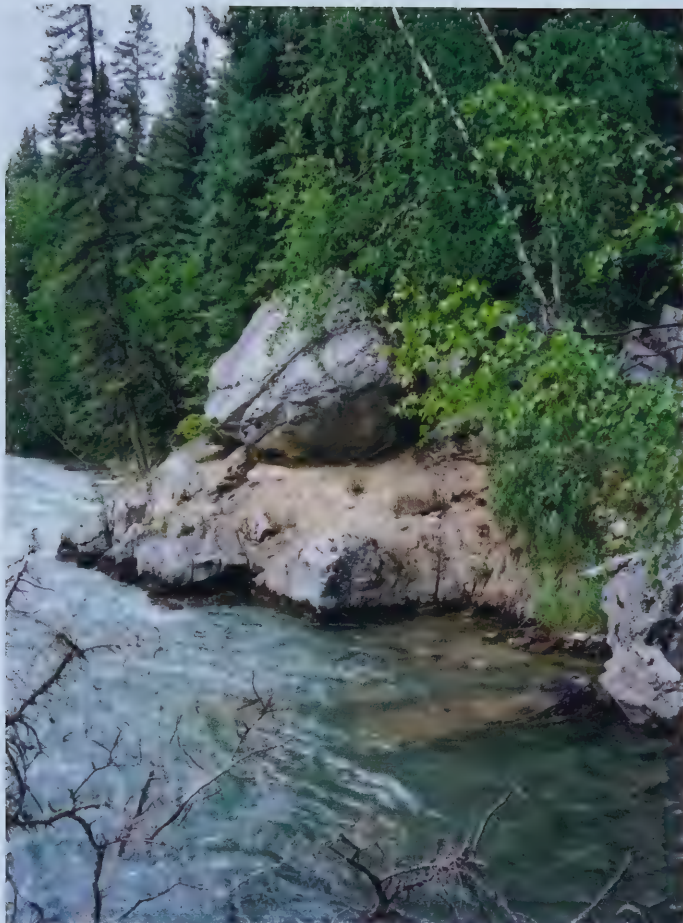
Figure 4.36 – Colluvial material in the Maligne River at the toe of the colluvial area of the Rock and Boulder Gardens. The large boulder is 2m high.

The upper colluvial area indicates that this feature is a rock labyrinth (Sokolov, 1963; Simmons and Cruden, 1980), by the sliding of blocks along bedding planes. The scarp of this labyrinth creates a wedge shaped feature in the landscape. Colluvium that has reached the slope break has toppled and some material has been deposited in the Maligne River.

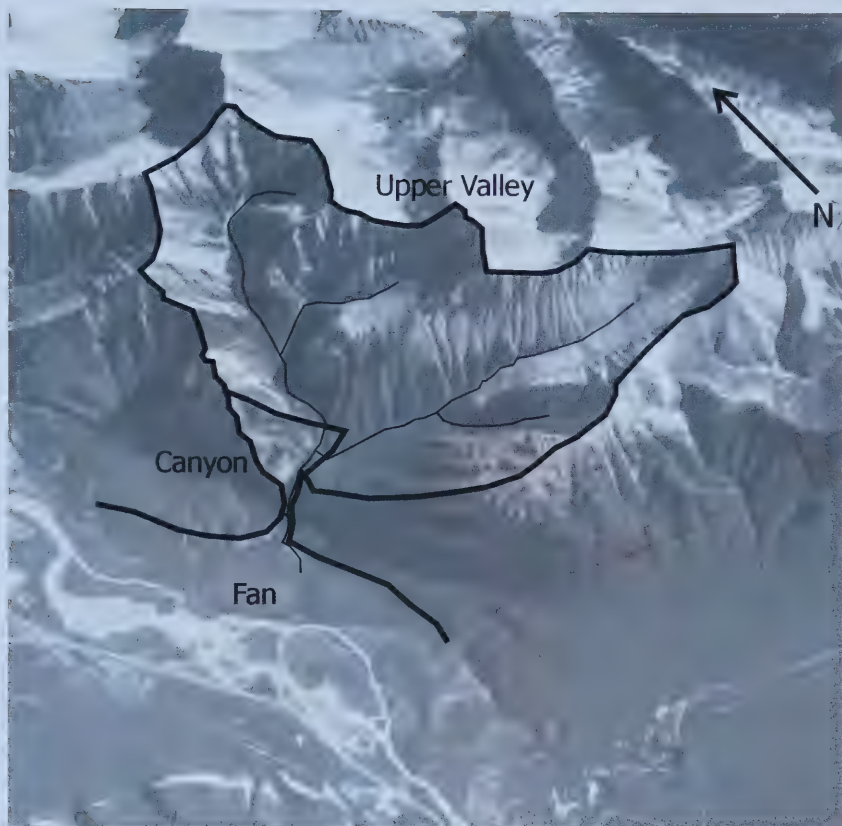
Figure 5.2 – Outline of Debris Flow Creek on airphoto A23015-139, showing the division of the area into the upper valley, the canyon and the fan.

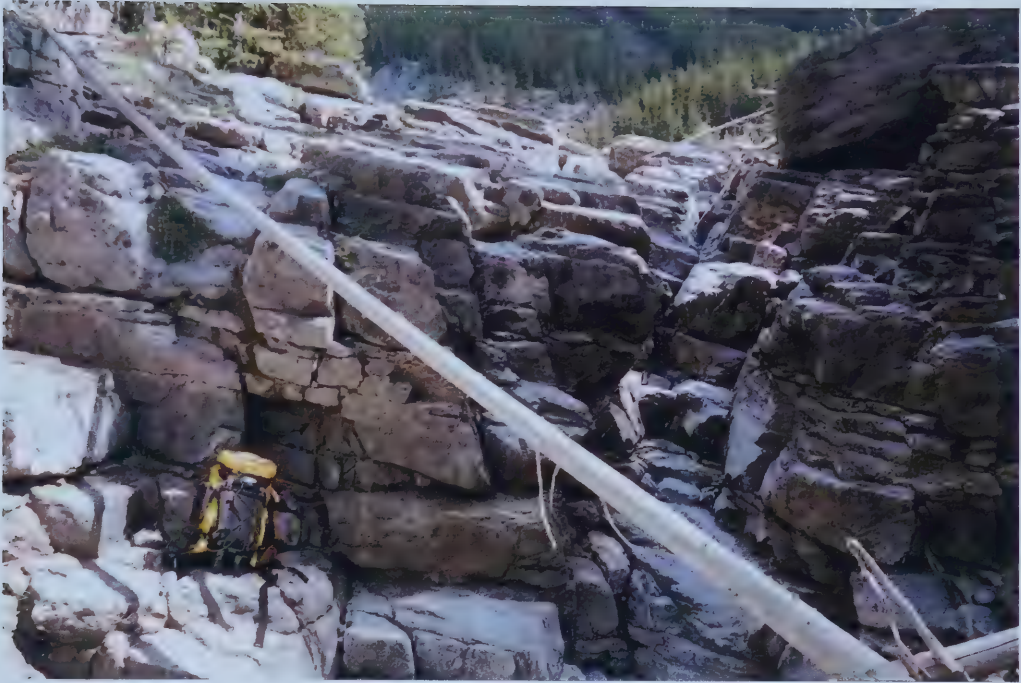
Figure 5.5 – Photograph of the bedrock at the top of the canyon. Note that the beds are gently dipping, with open joints.

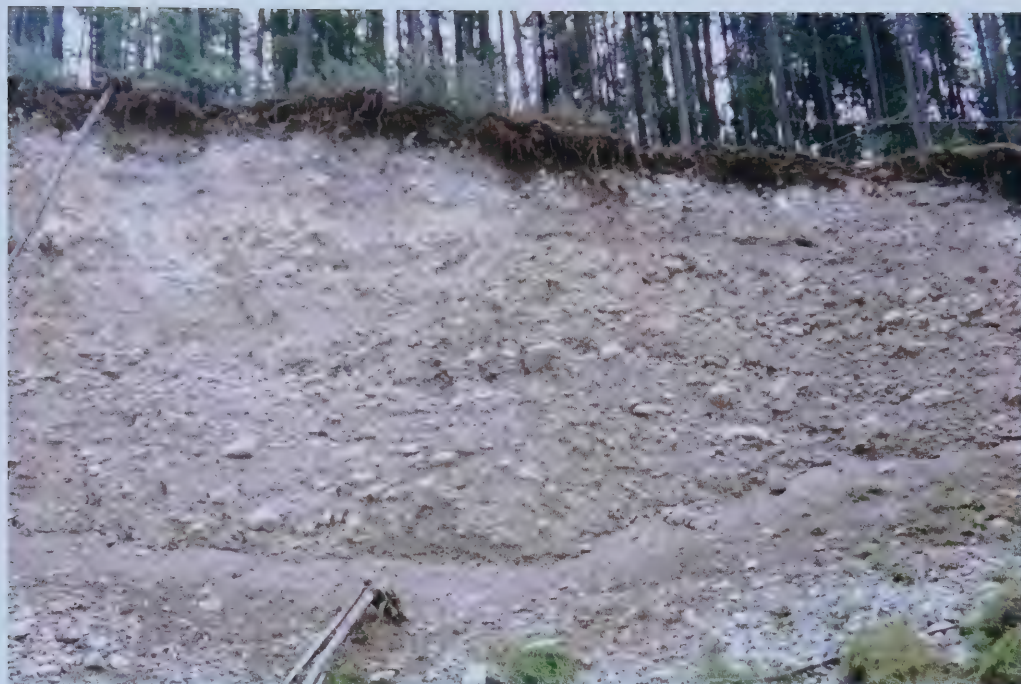
Figure 5.7 – Till deposits within the upper canyon, at the location where the large U-shaped valley meets with the main creek, near the top of the canyon.

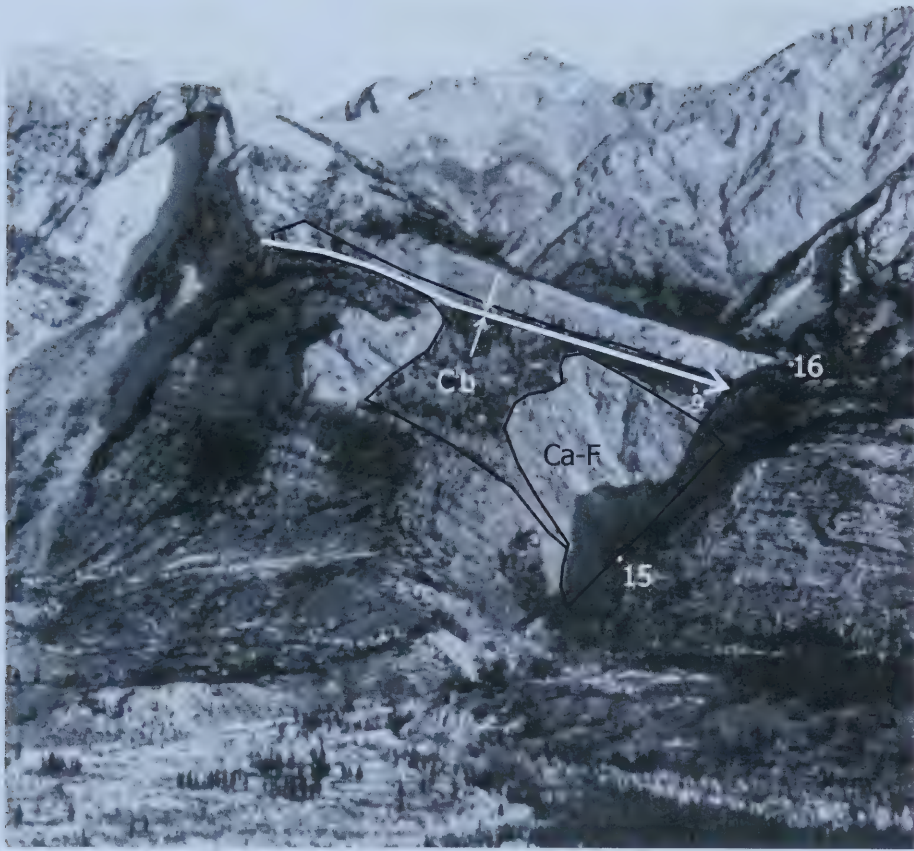
Figure 5.8 – Oblique photograph showing the location of the syncline adjacent to Debris Flow Creek. Photograph number 460 by M.P. Bridgland. The locations of Figures 5.9, 5.15 and 5.16 are shown, along with the different terrain units to the north of the creek.

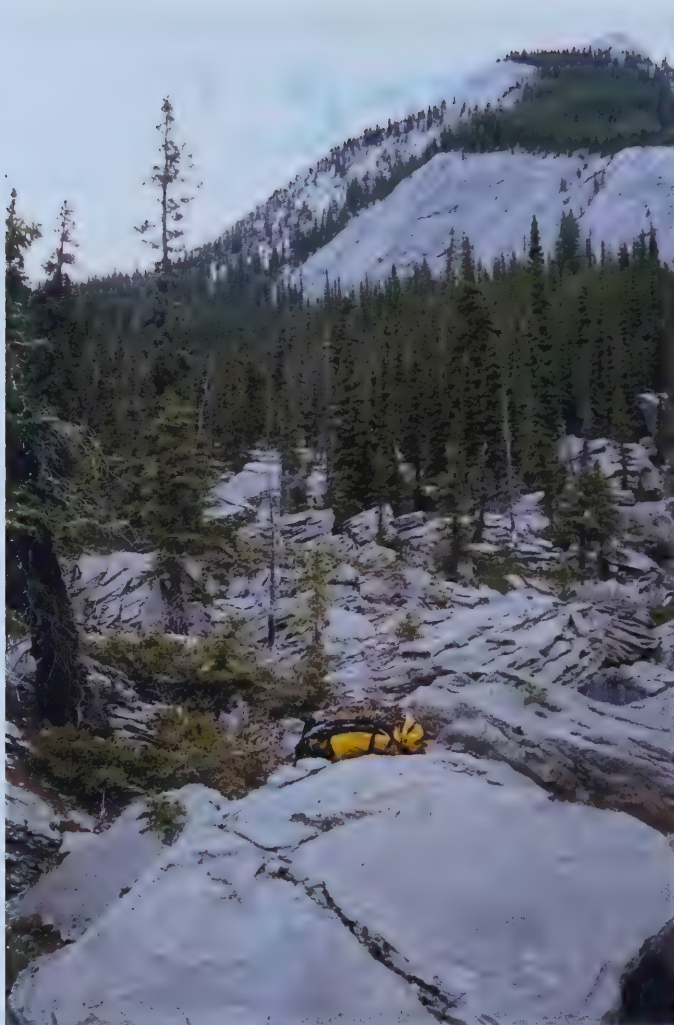
Figure 5.9 – Photograph of an area of large displaced boulders. Location of this photograph is on the east side of the syncline at the base of the cataclinal overthrust slope (Figure 2.8). Karren are present on the surface of the boulders, and can be seen on the boulder in the foreground. Pack is used for scale.

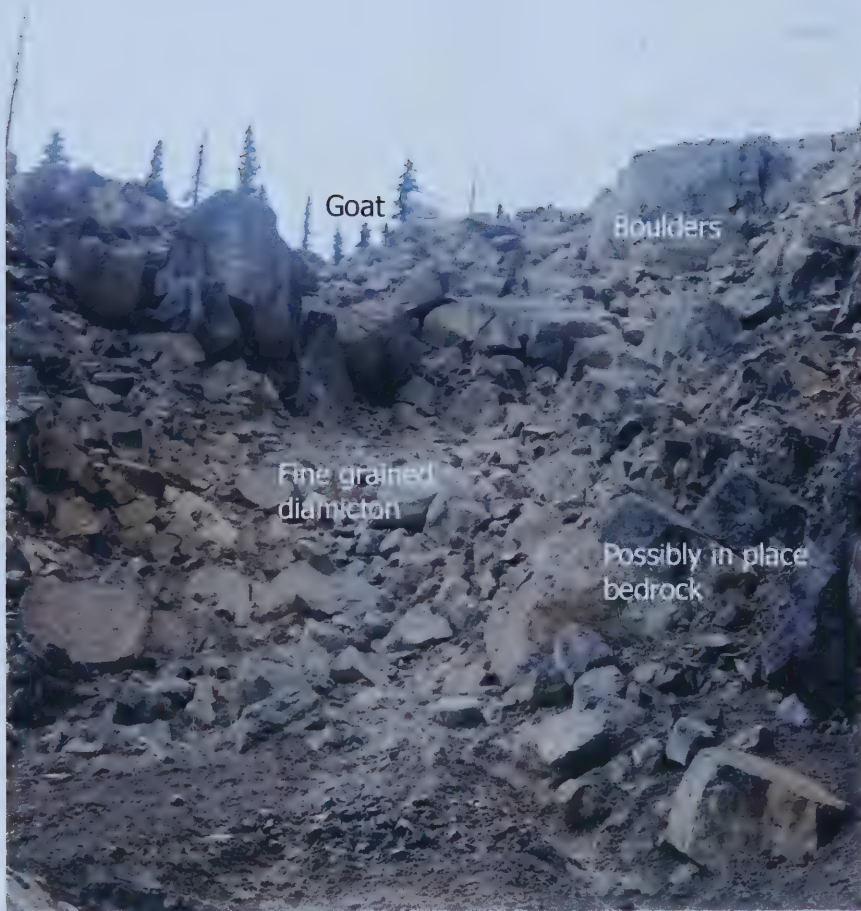
Figure 5.11 – Photograph of the north wall of the canyon, showing the colluvium that composes this wall. Notice the angular nature of the material, as well as the distribution of grain sizes. View is from the creek bed looking NE. The goat is for scale.

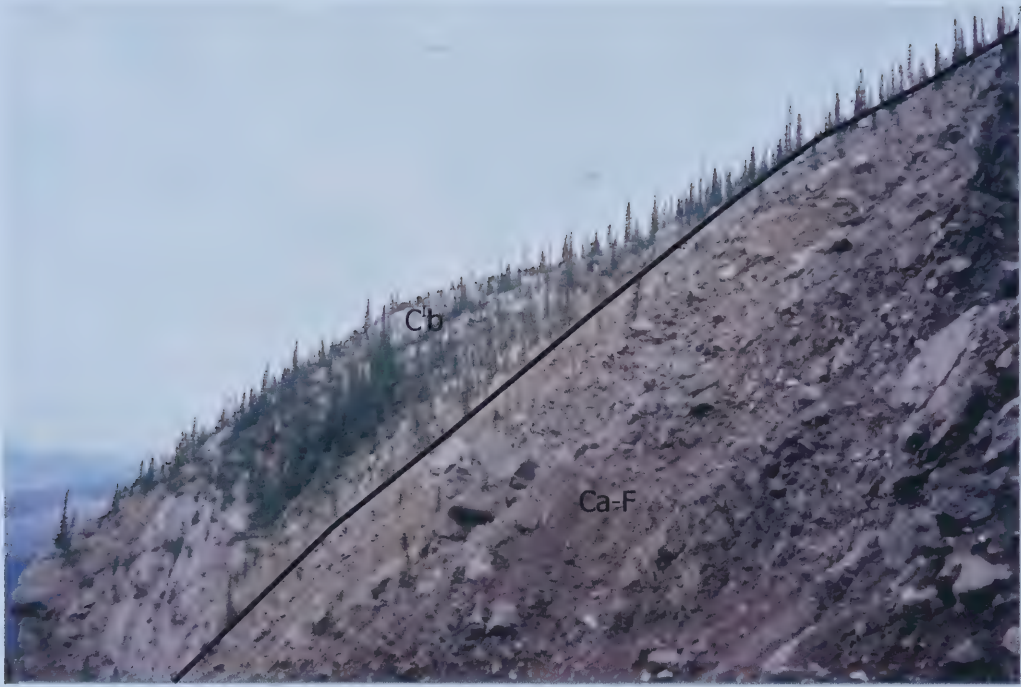
Figure 5.12 – The north slope of the canyon showing the difference in vegetation between the active and the inactive colluvium. Photograph is taken from the creek bed looking west, near the axis of the syncline.

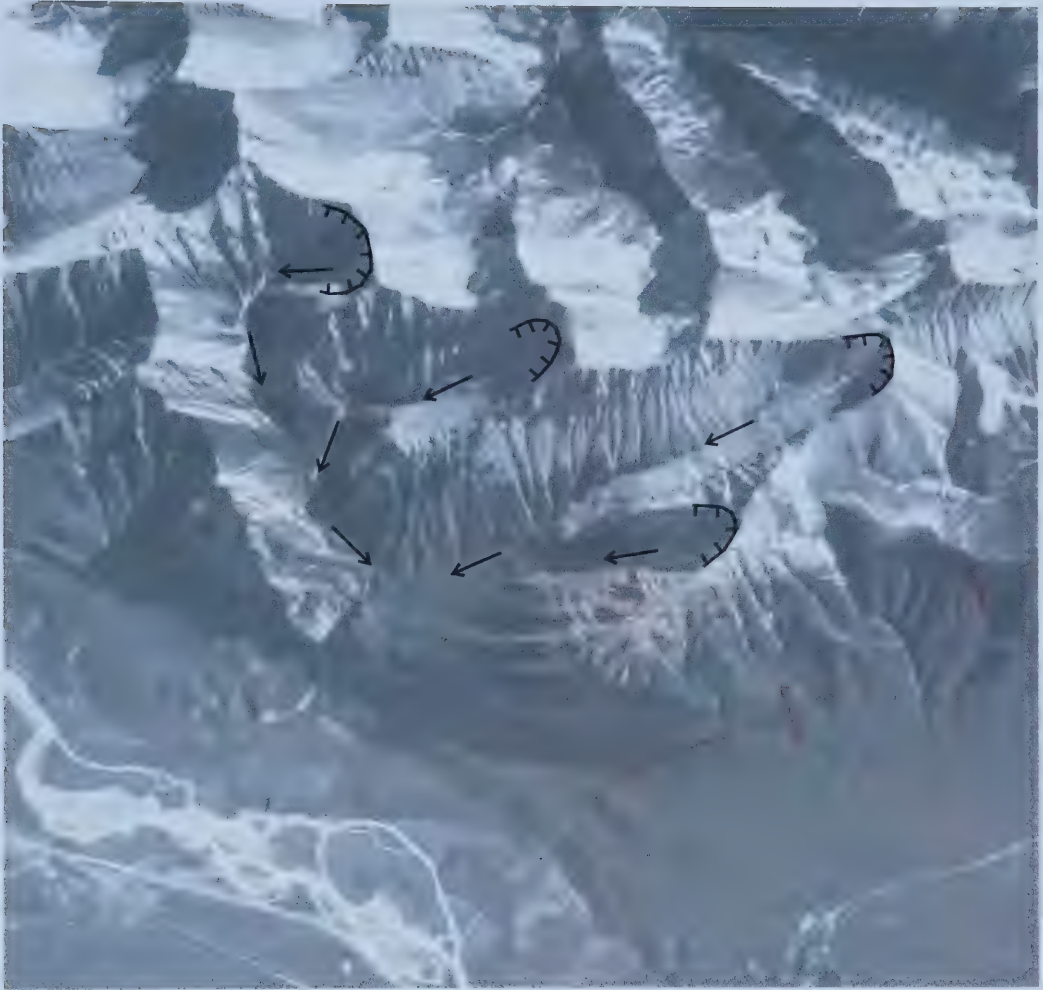
Figure 5.13 – Enlargement of air photograph A23015-139, showing the location of the heads of the cirques within the watershed of Debris Flow Creek, and the corresponding direction of ice flow. The headwalls of the cirques are orthoclinal slopes, and are indicated by the black lines, with the hatch marks indicating the direction of the slopes.

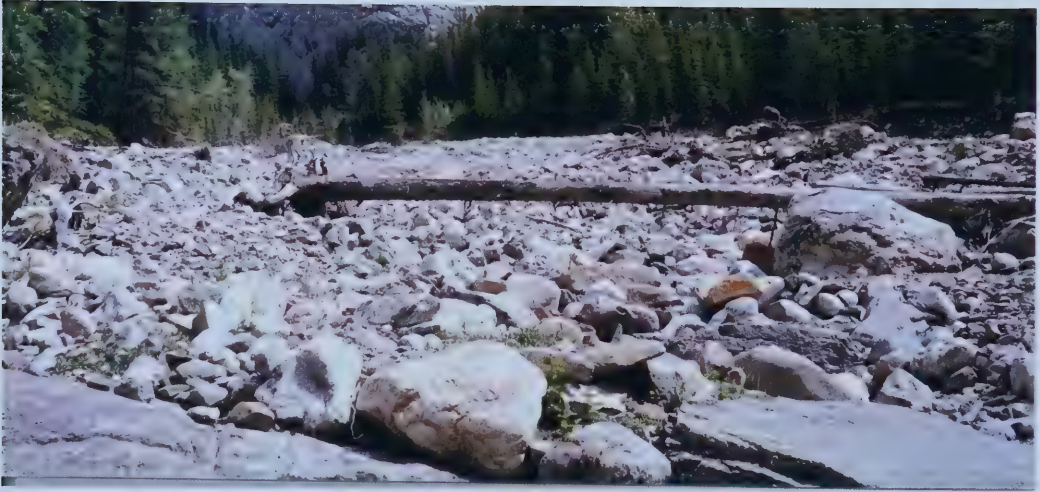
Figure 5.16 – Photograph of the sediments in the upper valley, taken from the location of Figure 6.15, at the top of the canyon, where the upper valley starts. Notice the rounding, and the well sorted nature of the sediments. Photograph is taken from the narrow top of the canyon, looking upstream to the east.

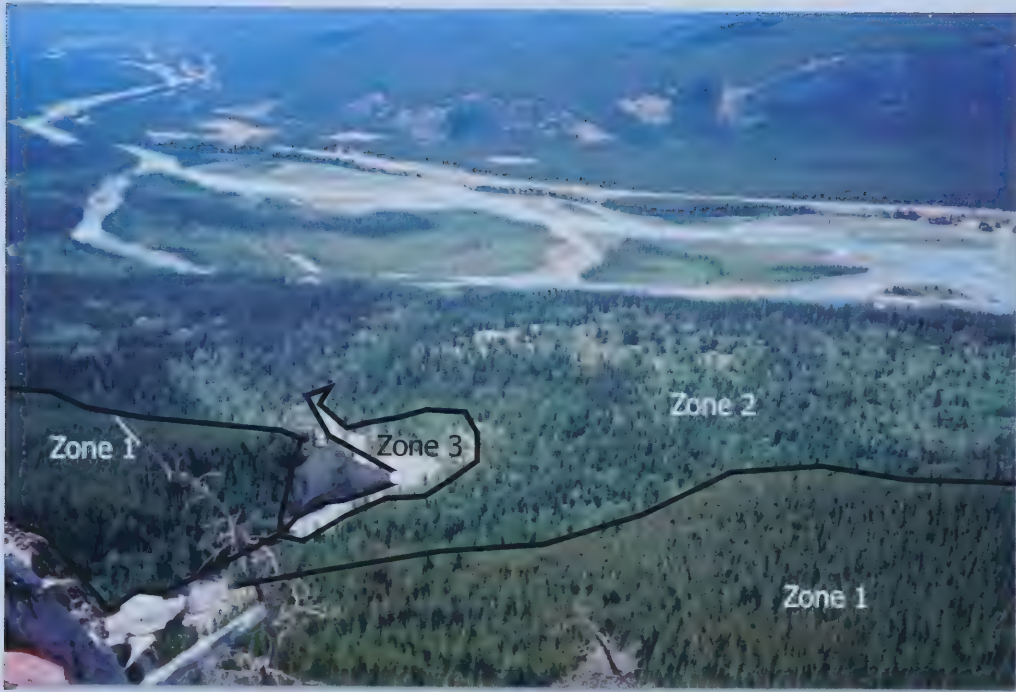
Figure 5.17 – Photograph of the fan of Debris Flow Creek. Vegetation Zone 1 is dominated by coniferous trees, Zone 2 is mixed coniferous and deciduous trees and Zone 3 is mostly unvegetated, with Poplar trees making up the majority of the vegetation. The location where the creek changes flow direction around the till is shown with a white dot.

Vegetation varies greatly over the area of the fan. As seen in Figure 5.17, there are three vegetation zones present within the fan area. The first type of vegetation, Zone 1, is Douglas Fir. Douglas Fir are common along the outer

One other feature of interest, seen on Figure 5.17, is where the current creek cuts the base of the lateral moraine left by the Athabasca Glacier (Mountjoy, 1974). At this location, the creek changes flow directions from westerly to southerly and is incised 2m into the fan. The creek flows underneath the northern extension of the till (Figure 5.21), and has cut a

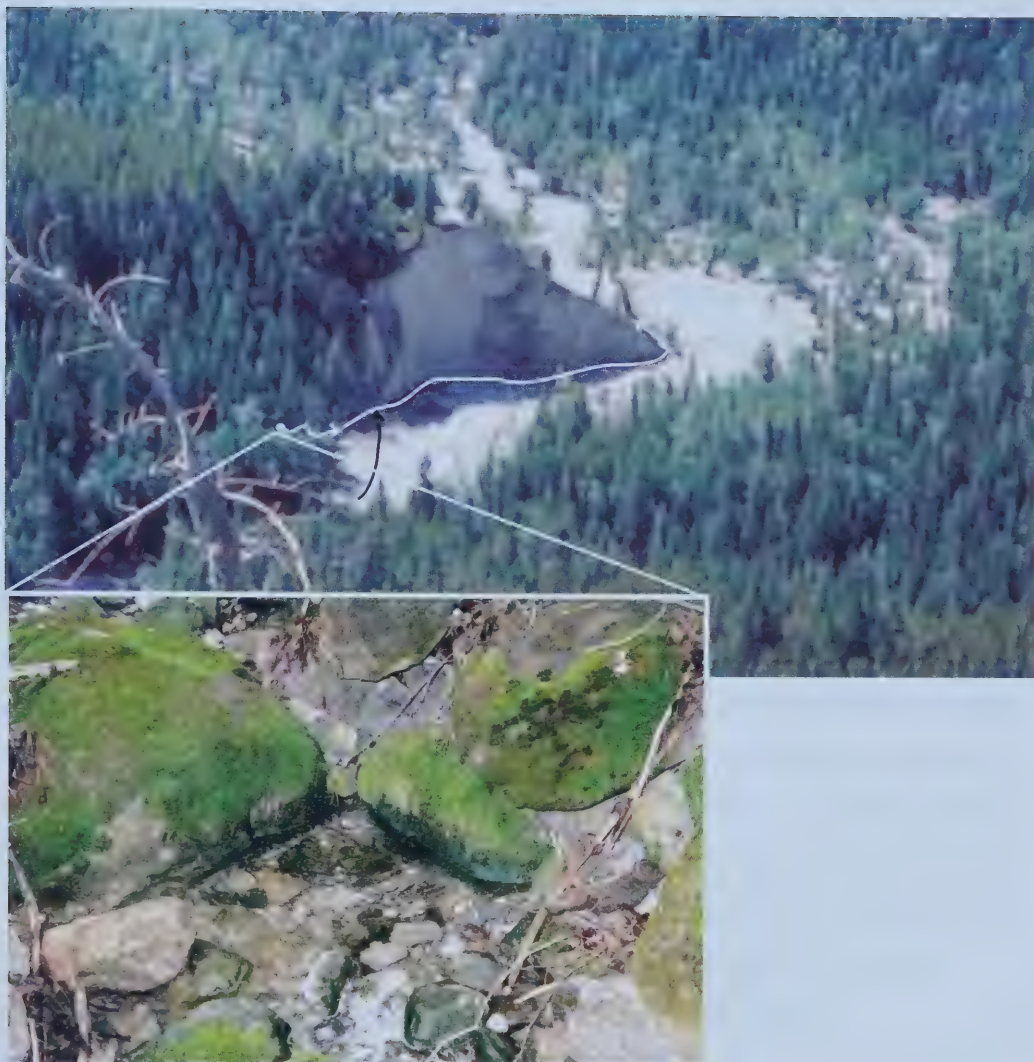
Figure 5.18 – Location of the spring system on the alluvial fan, showing the spring and the regularly flowing stream at the base of the till in white. The intermittent stream location is shown in black where the two creeks meet. The inset is a photograph of one of the springs.

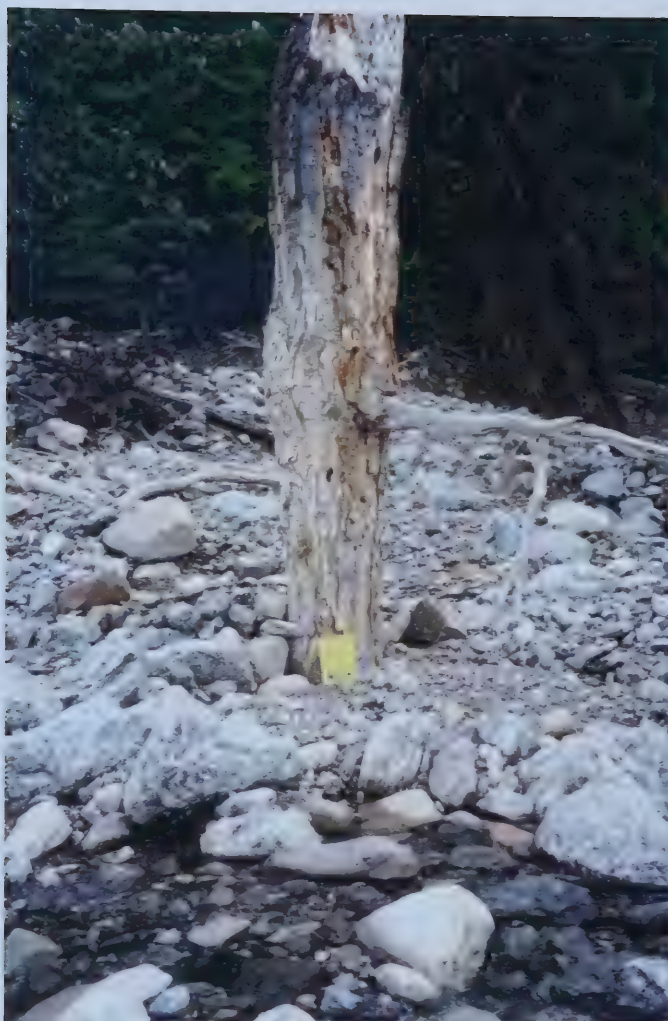
Figure 5.19 – A poplar tree showing roots that are exposed above the surface of the ground. The location of the photograph is in the fan area, downstream from the glacial till deposits.

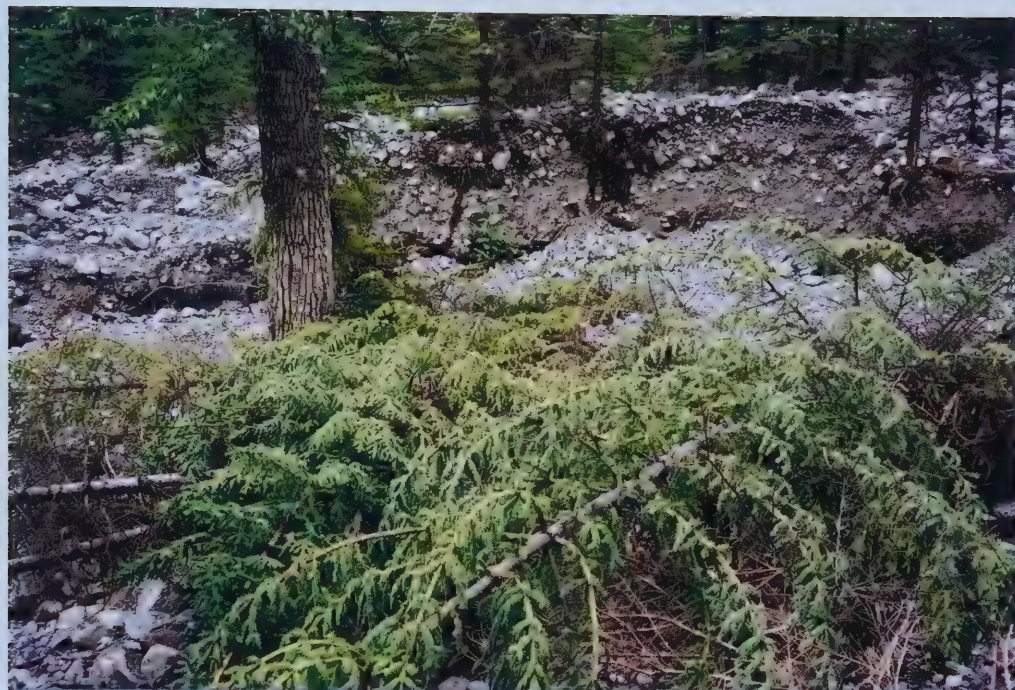
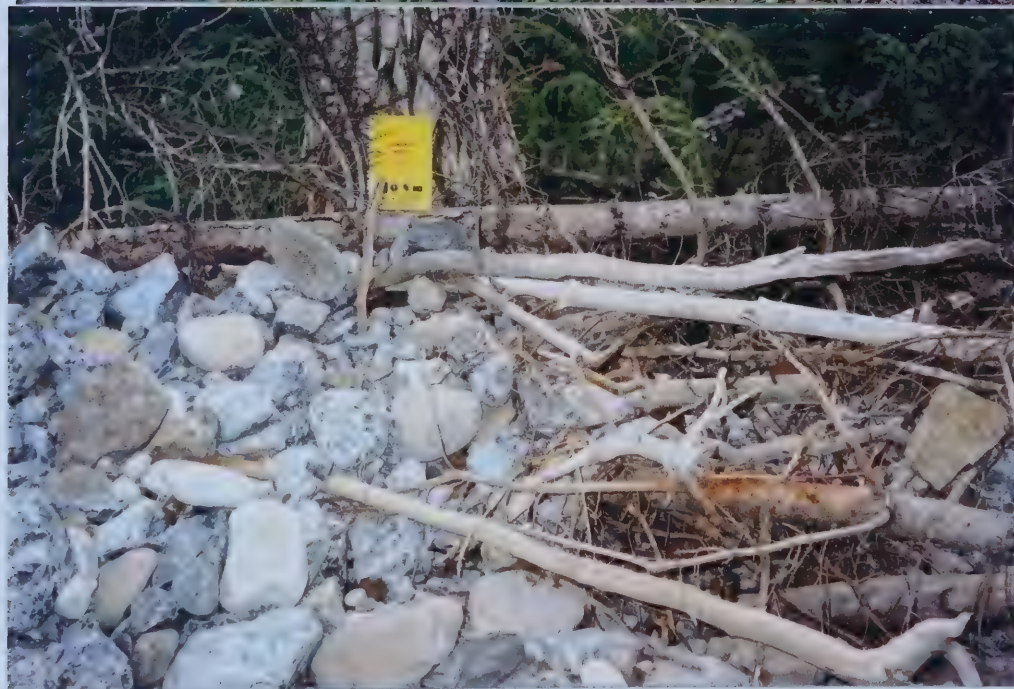
Figure 5.20 – Several trees that have recently been knocked over, and the accumulation of debris on the upstream side of a tree trunk on the alluvial fan. The presence of needles on the fallen tree indicate that this event is no older than 2-3 years old.

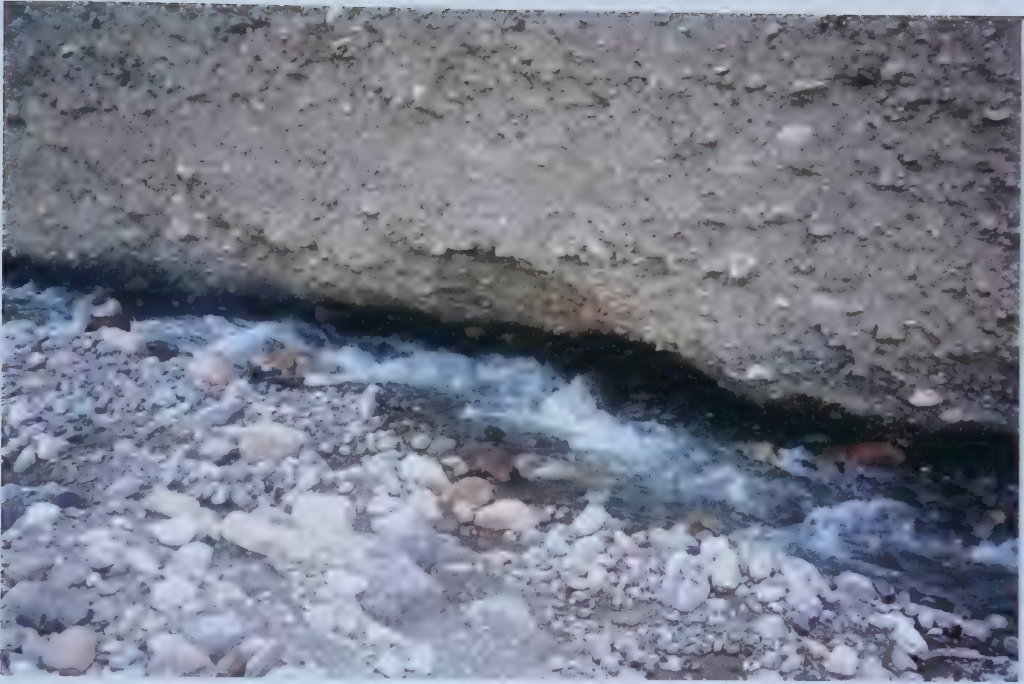
Figure 5.21 – The current creek flowing underneath the edge of the till, a few metres upstream from the 90 degree turn of the creek. The creek has cut roughly 1 m into the unit.

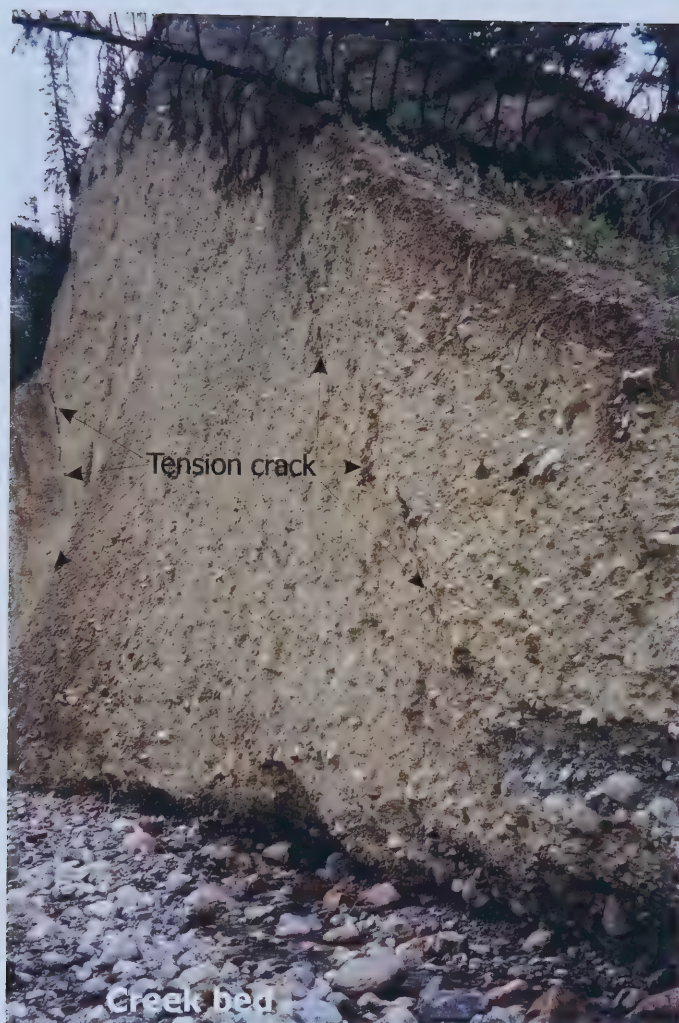
Figure 5.22 – Cracks in the till above where the creek is undercutting the till.

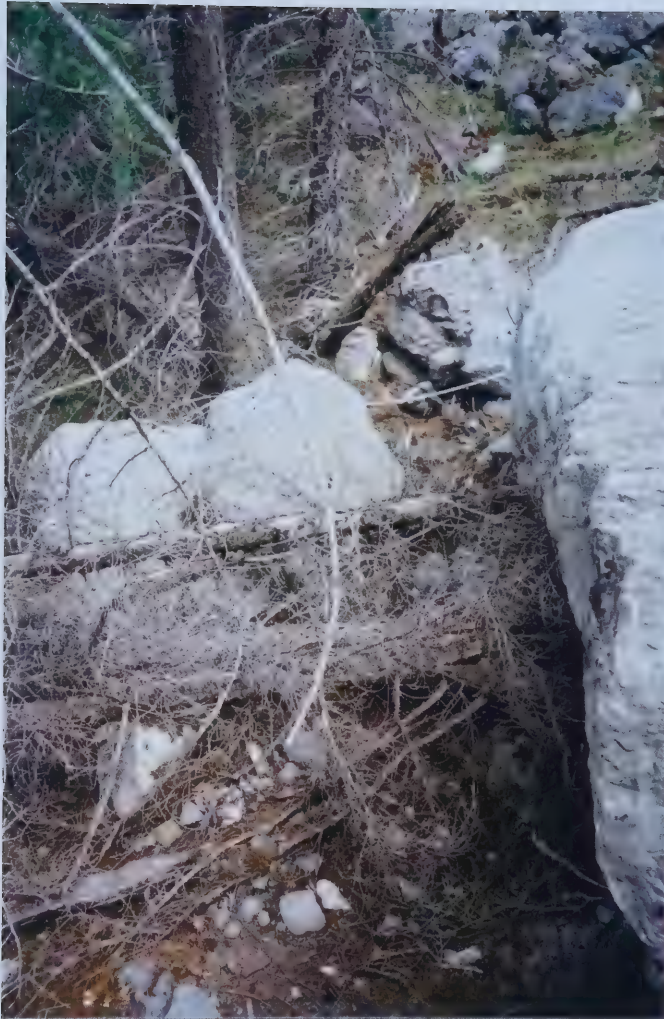
Figure 5.23 – Dead trees in front of a large boulder at the downstream extent of the deposit. The boulder on the left side of the photograph is 175cm long. Photograph is taken in a direction perpendicular to the inferred flow direction.

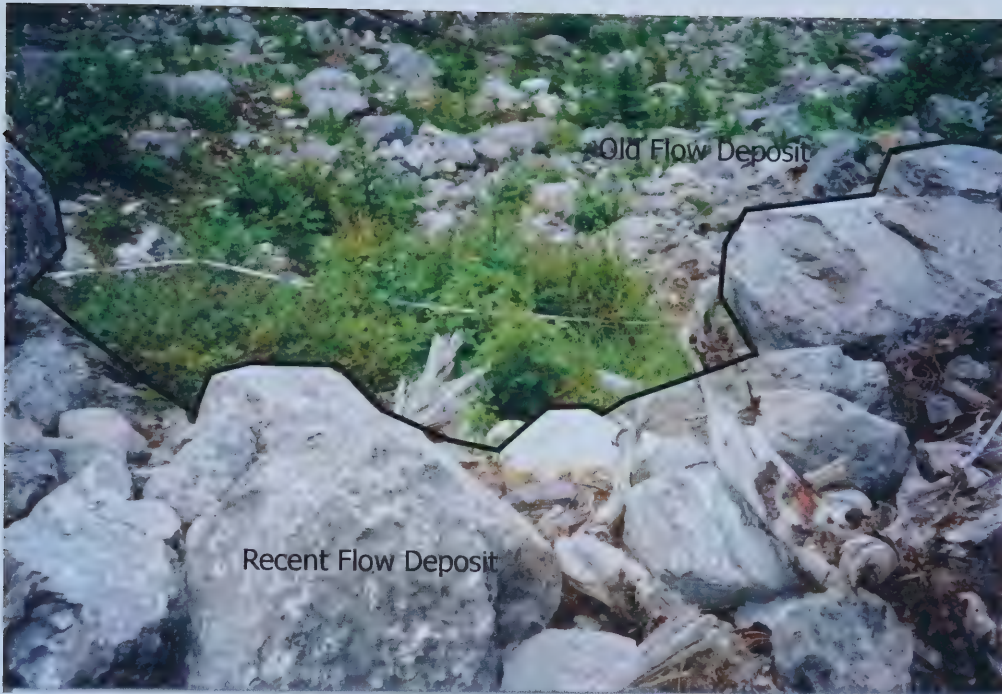
Figure 5.25 – Photograph of vegetation adjacent to the deposit. The thick black line shows the boundary of the deposit. Vegetation is likely 10-15 years old. The tape measure in the photograph is 1.2cm wide.

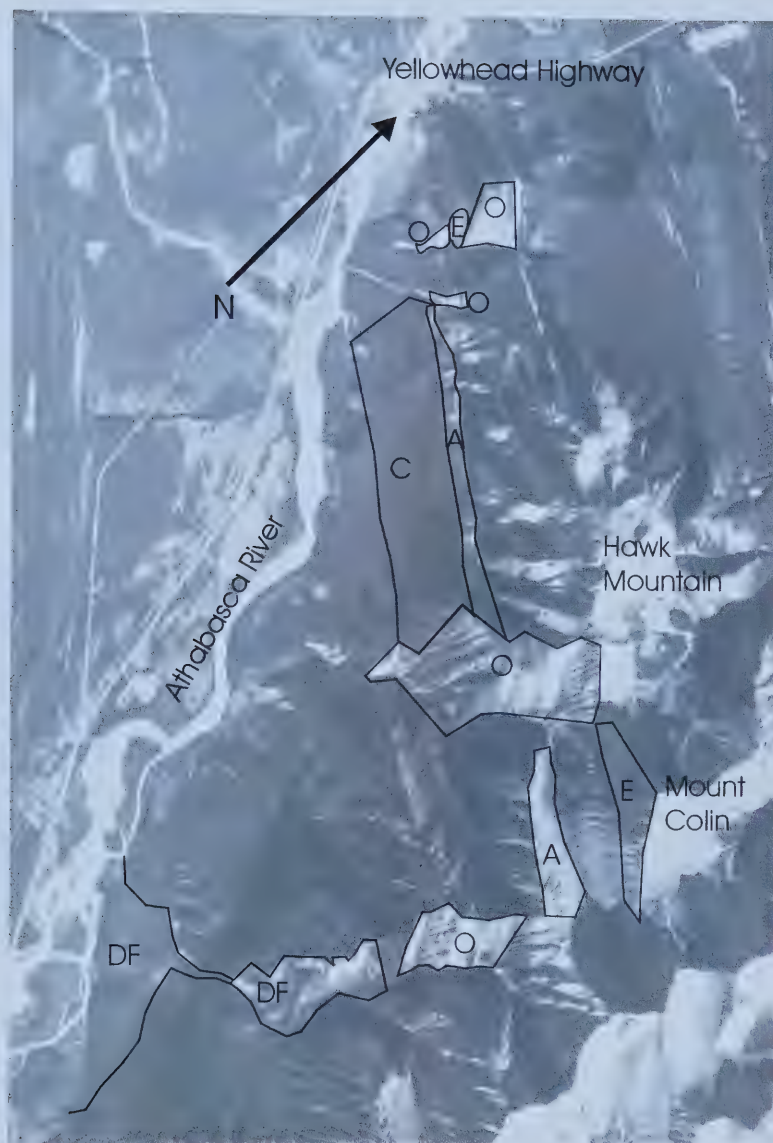
Figure 6.1 – The west slope of the Colin Range, Jasper National Park, showing areas of exfoliation, E; orthoclinal toppling, O; cataclinal toppling, C, anaclinal toppling, A and debris flow deposits, DF, overlain on part of aerial photograph A23025-138, Natural Resources Canada. Original photograph has a scale 1:60 000.

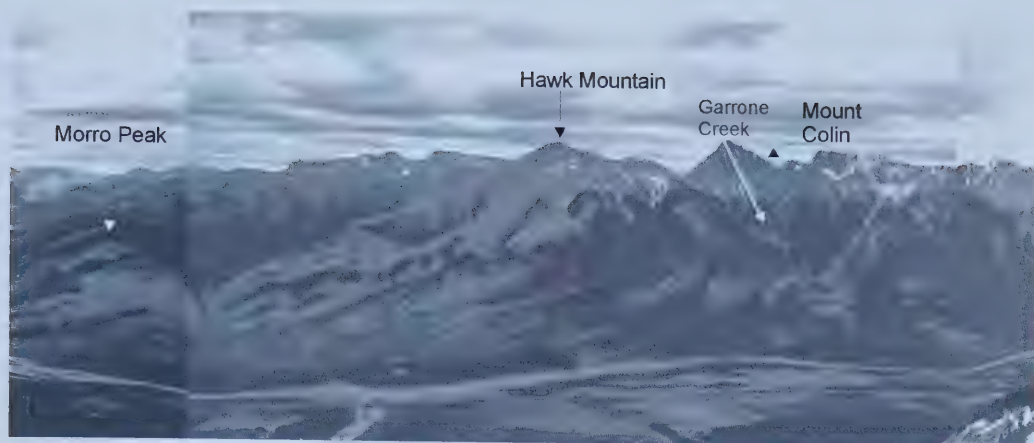
Figure 6.2 – View of the Colin Range from the Palisades repeat photography set from the Bridgland collection. The upper set of photos is the repeat set from 1999, photos 470 and 471, and the bottom photograph is that of Bridgland, 1915, photo numbers 470 and 471 (Higgs, 2001).

Figure 6.2 is a set of repeat photos from the Bridgland collection, showing the north part of the area in Figure 6.1. The figure was composed using two photographs from the Bridgland collection, creating a panoramic photograph of the area in both 1999 and 1915. The photographs are examined in detail in the areas where slope movements have been documented.

The main location of toppling on cataclinal slopes is along the west slope of the Colin Range, where the Athabasca River cuts the range at an angle that is oblique to the geological structure of the area, and is discussed in detail in Chapter 4.2. Figure 6.2 covers the majority of this area that is currently experiencing toppling on cataclinal slopes. For the most part, from the

observation of these photos, toppling blocks on these slopes can not be seen. However, the 1999 photographs do show areas where there is no vegetation. These are where toppling is occurring on these slopes and where toppled rocks are falling. Yet, these locations are not the only locations on this slope where toppling occurs (Chapter 4.2).

Garrone Creek is an area of active toppling on orthoclinal slopes. The creek can be seen near the centre of the photographs in Figure 6.2. Again, the presence of active toppling can not be readily determined from these photographs, yet this area appears as unvegetated in the 1999 photographs as in the 1915 photographs. A change in the slope due to orthoclinal toppling can not be determined from these photographs.

is 164mm (Bridgland, 1924). The distance to the central object is determined on the 1:50 000 topographic maps. The scale of the photograph in Figure 6.2 is 1:30 488 at the centre of the photograph, so a topple would need to be 300m on the ground in order to show up as 1mm on the photograph. The scale is valid for the central portion of the photograph, yet image displacement occurs away from the centre of the photograph, resulting in a distorted, smaller scale at the edges of the photograph.

In Figure 6.2, any change that is greater than 48m would appear as greater than 1mm on the photograph, and in the case of Figure 6.6, any change in the centre of the photo that is greater than 20m will appear larger than 1mm on the photographs. One square millimetre on the photograph is composed of 1521 pixels, indicating that this area can be enlarged, and not much detail is lost. With the increase in the sophistication of digital photography, digital databases of repeat photographs will increase in quality, and prove to be able to detect smaller changes. The smallest feature that is resolvable on the glass plate slide negatives is roughly 1m on the ground. Much of this detail is lost in the development of the photograph and the subsequent scanning of the photograph into the digital database.

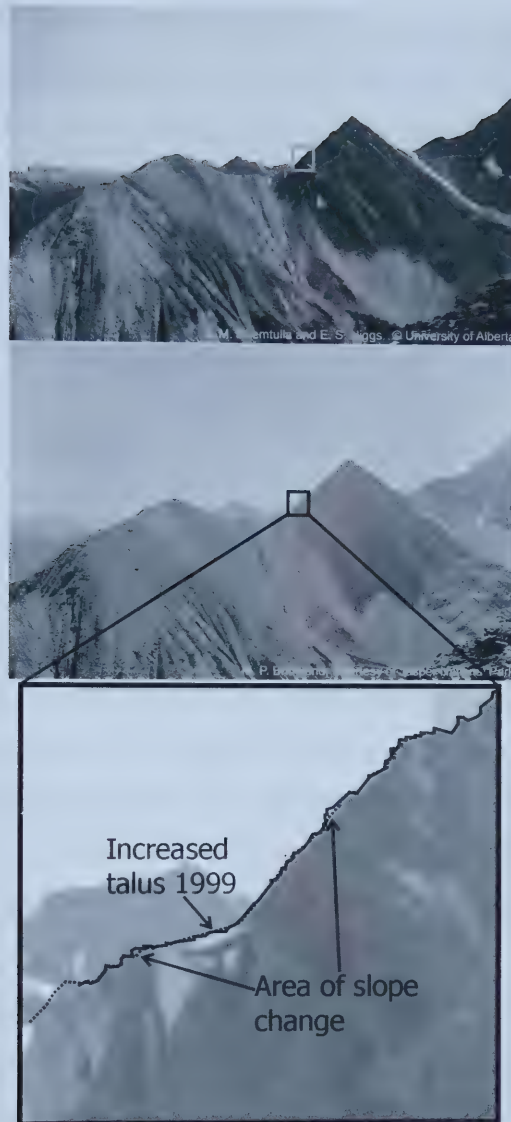
Figure 6.3 – Original and repeat photographs number 336 showing the enlarged area shown at the bottom, with Rhemtulla and Higgs photograph in front of Bridgland’s photograph. The dotted line corresponds to the slope profile of the 1999 photograph, and the solid line corresponds to the slope profile in the 1915 photograph. The areas where the slope profile differs are shown in the figure. In addition, there is more talus in the 1999 photograph than in the 1915 photograph.

Toppling on anacinal slopes occurs on the northeastward facing slopes of the Colin Range, which are not visible on Figure 6.2. From photographs shown in Figure 6.3, changes due to anacinal toppling can be seen along the creek that runs along the southwest face of Hawk Mountain. Changes were observed using Corel Draw, creating layers for both of the photographs, which were overlapped (Figure 6.3). New layers were added, one where the slope profile was traced on the 1915 photograph, and a fourth layer was created to trace the slope profile on the 1999 photograph. The two slope profiles were then compared, showing a change in the slope profile, indicating that at least one large block moved from the slope, with the most likely mode of movement being toppling. This slope on map 83E/1 is anacinal. The skyline portion of the slope was used to determine the change in the slope profile, as the contrast with the sky makes it much easier to pick out detailed features.

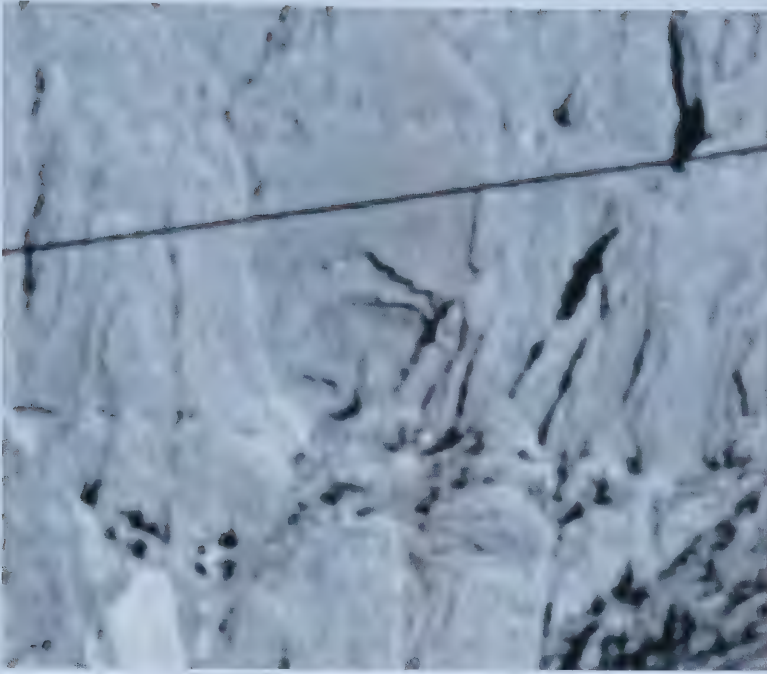
Figure 6.5 – Area of exfoliation on the face of Morro Peak, enlarged from Bridgland photo 470 on the top, and enlargement from photo 467 on the bottom. The photographs have been enlarged 400% to make the exfoliations visible. The individual bedding planes create the flat, planar surfaces above the depressions.

Exfoliation has occurred at two locations, as documented in Chapter 4.3. Both exfoliations occur near the base of steep cataclinal underdip slopes, formed in steeply-dipping, bedded sedimentary rocks. The results of this mode of movement cannot be easily observed on aerial photographs, as the features are on extremely steep slopes. This mode of movement occurs under a ledge along a cataclinal underdip slope, leaving the appearance of an undisturbed slope from above (Figure 6.4), depending on the angle of slope and the angle to the slope from the camera. Exfoliations can be observed on terrestrial photographs with relative ease (Figure 6.5).

Within the exfoliated area, no definite change was noted. With exfoliation, the skyline cannot be used to determine whether or not the slope is changing. The scale at the centre of this photograph is the same as that of Figure 6.2, giving a scale of 1:30 488 without enlargement, again indicating that in order for a change in the slope to be visible in this photograph, 300m of material would need to be moved in order to see a 1 mm change in the photograph.

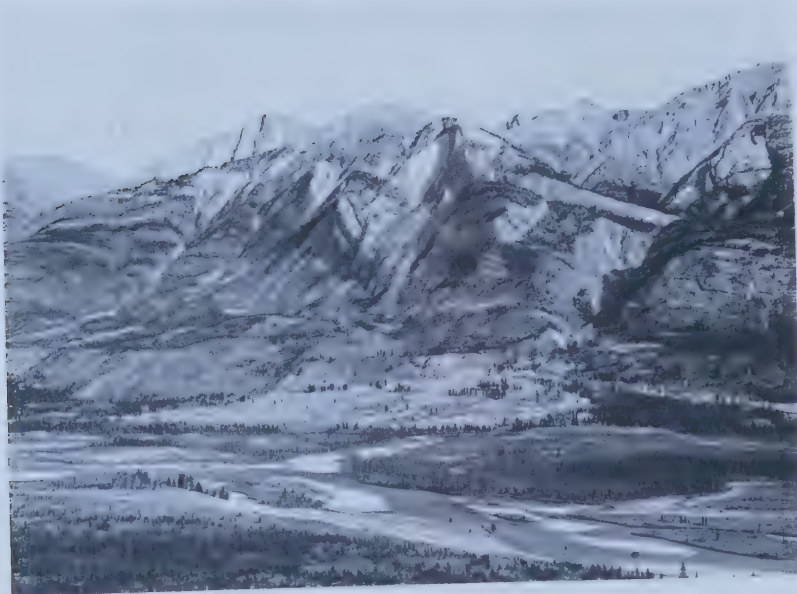
Figure 6.6 – Set of repeat photographs, photos #460, with the top photo from Higgs and Rhemtulla, and the bottom photograph by Bridgland. The photograph shows the area of Debris Flow Creek.

As can be seen in the set of photographs of Figure 6.6, the vegetation in the area of Debris Flow creek has changed over the 84 year time period. This change is especially notable on the alluvial fan of the creek, where coniferous trees have replaced the deciduous trees. Minor changes can be observed in this area between the two photos (Figure 6.7). The first area where slope movement can be inferred is the area on the north side of the creek canyon, where vegetation is not present on either of the photographs (Figure 6.6). This is an area of colluvial deposits which are constantly being reworked by the creek and by further mobilization of the colluvium under gravitational forces (Chapter 5). This area is one of the main contributors to the intermittent debris flows that occur at this location.

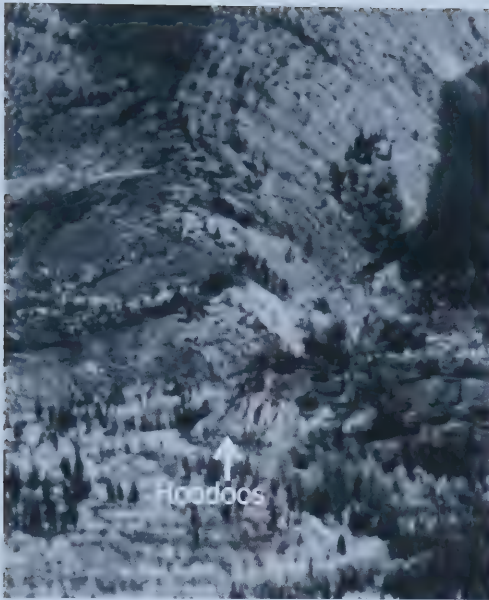
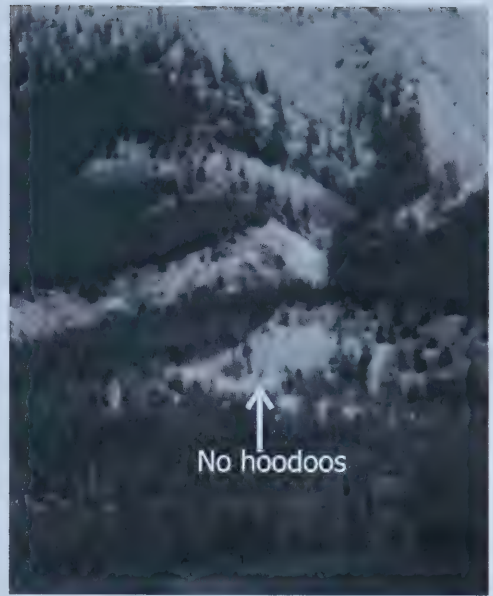
Figure 6.7 – Enlarged 200% repeat set of photograph number 460, with the original photo on the left and the repeat photograph (Higgs and Rhemtulla) on the right side. Vegetation changes are easy to see of the alluvial fan, and the changes in the moraine include the removal of the hoodoos over the 85 year time span between the photographs.

Another area where change can be observed on these photographs is the area where the creek cuts through the till deposits, left from the retreat of the Athabasca Glacier (Mountjoy, 1974). The till face on the south side of the alluvial fan has been altered between 1915 and 1999 (Figure 6.7).
